Integrated assessment of the buried wreck site of the Dutch East Indiaman 't Vliegende Hart

Tine Missiaen¹, Ine Demerre² & Valentine Verrijken³

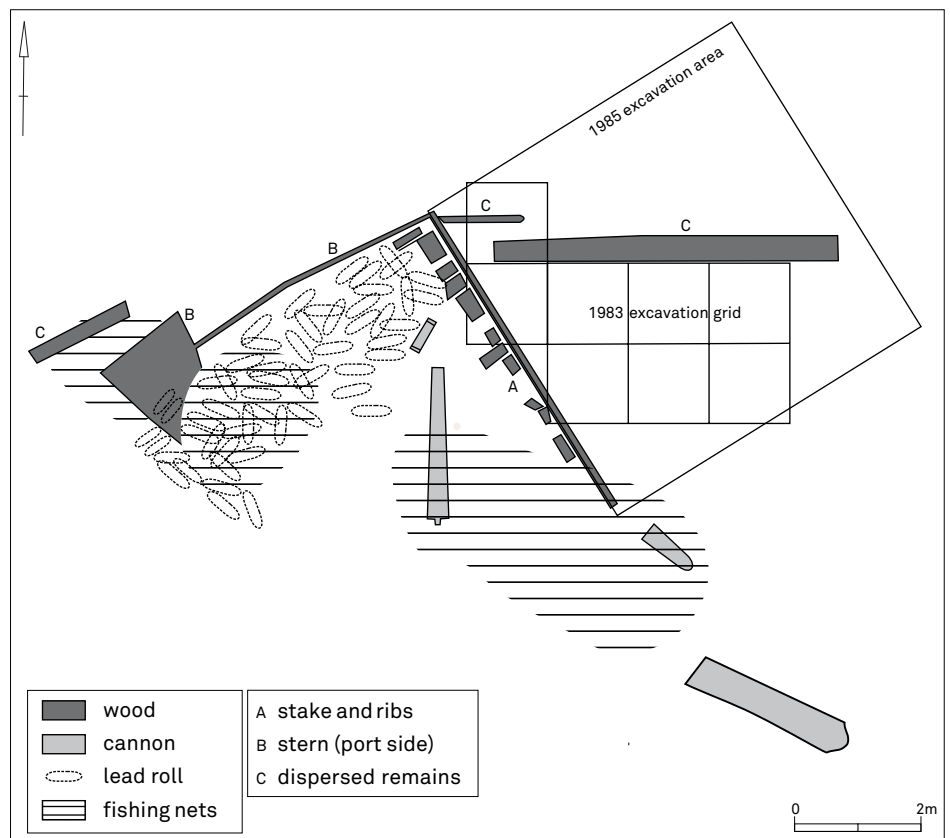
Structural fragments found in 1983 included remains of the stern and hull on the port side (fig. 5). They can most likely be linked to the lower hold of the ship. The fragments indicate that the stern lays inclined to the port side at an angle of 55 degrees⁴⁰. Further to the southeast three cannons, various lead rolls and fishing nets were found (fig. 5). The western side of the wreck site showed an abrupt slope, while towards the east the slope was more gentle⁴¹.

FIG. 5 Remains of *'t Vliegende Hart* wreck site observed during diving investigations in 1983 (after Gawronski & Kist 1984). Structural fragments include a.o. wooden fragments of the stern (B) and hull (A). Nearby also several cannons and a large number of lead rolls were found, partly covered by fishing nets. The 1985 excavation area is also shown on the right (after Sills Consortium Recoveries Ltd 1985). *Overblijfselen van het wrak van 't Vliegende Hart zoals blootgelegd tijdens het duikonderzoek in 1983 (naar Gawronski & Kist 1984). Houten fragmenten van de opbouw zijn o.a. afkomstig van de achtersteven (B) en de scheepsromp (A). Vlakbij werden ook een paar kanonnen en een groot aantal loden ballastrollen gevonden, gedeeltelijk bedekt door vissersnetten. Het opgravingsgebied uit 1985 is ook aangeduid rechts (naar Sills Consortium Recoveries Ltd 1985).*

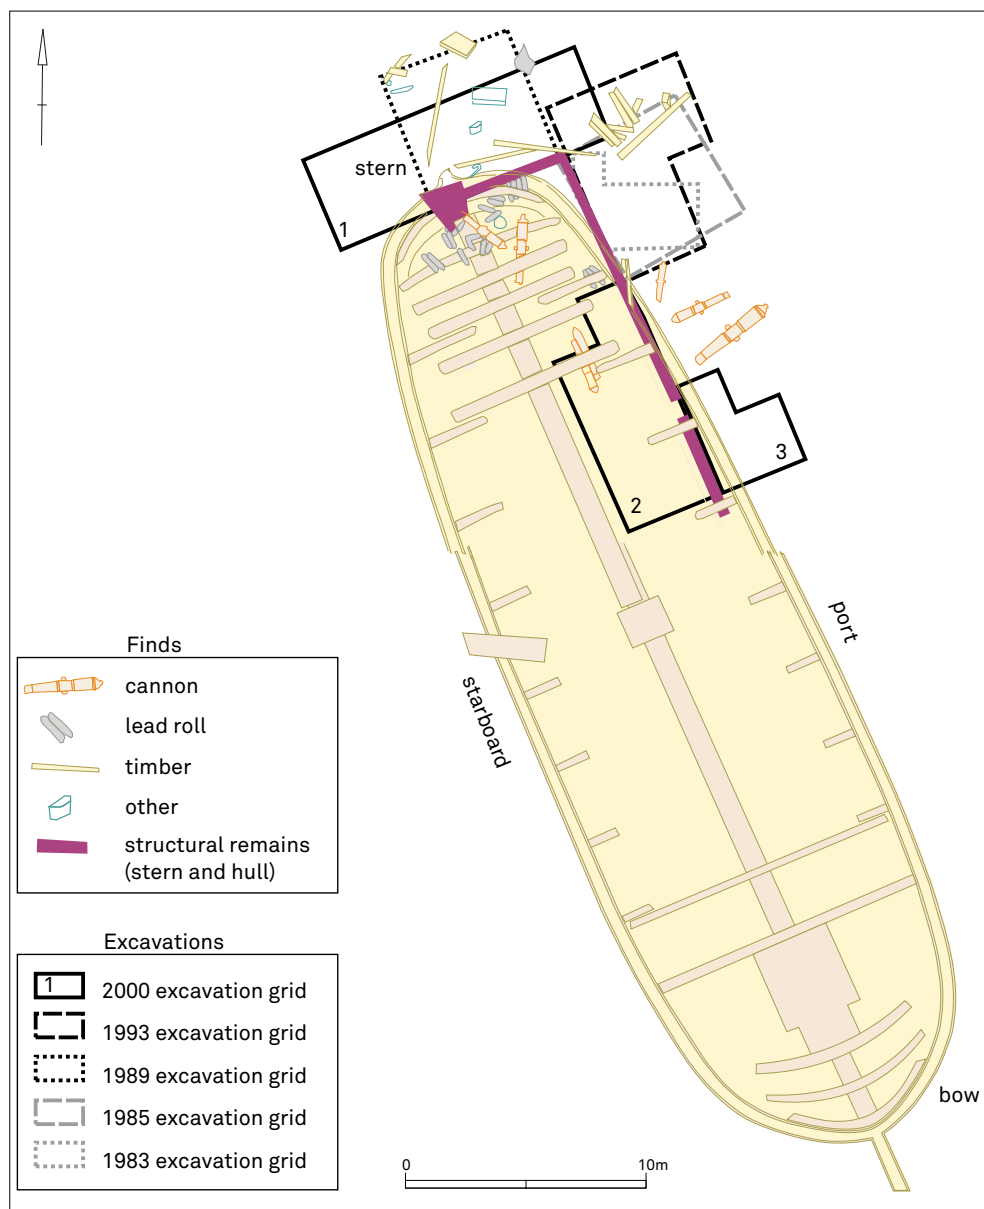
In 2000 three extra trenches were excavated near the sternpost and on the port side of the wreck (see fig. 6)⁵¹. The excavated areas were located both inside and outside of the wreck structure. The results confirm that the main stern remains are located between the sternpost and the port side. There seems to be no indication of a collapse of the port side to the east. The inclined sternpost protruded roughly 0.5 m above the surrounding seabed. Fishing nets, chains and ropes were found tangled around the sternpost. The structural remains of the hull confirmed the large gap roughly 12 m south of the stern⁵².

FIG. 6 Schematic drawing of the wreck based on historical drawings and excavation works in 1988-1993 (after 3H Consulting Ltd 2005). Different finds are indicated. Black and grey rectangles mark the trenches excavated in 1983, 1985, 1989, 1993 and 2000 (trench 1, 2 and 3). The structural remains of the stern and hull are marked in purple.

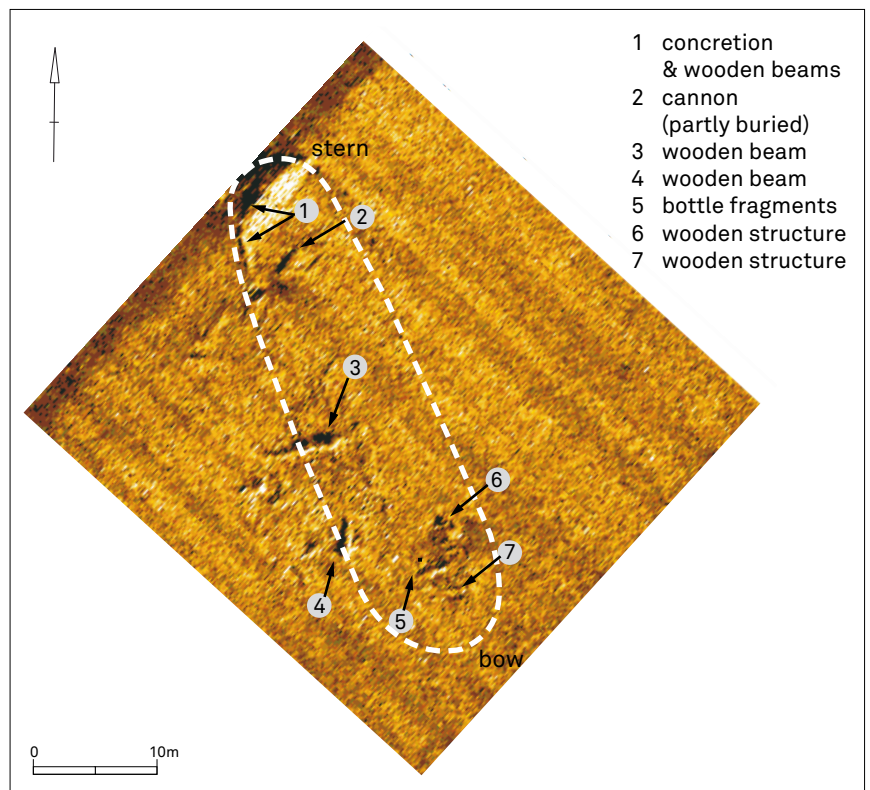
FIG. 7 Side-scan sonar image obtained in 2009 from the 't Vliegent Hart wreck site (courtesy by RCMG). The dotted line marks the (supposed) outline of the ship based on 1993 data (see fig. 6). The stern remains stand out clearly at the top. Different smaller fragments protruding from the seabed are observed near the bow. Elongated features are most likely due to wooden beams or cannons. Numbered arrows refer to some of the wreck remnants observed in 2010 (see fig. 9).

Many of the wreck remains observed on the seabed in 2010 correspond well with prominent features on the side-scan and multibeam data from 2009 (see numbered arrows in figs. 7 and 8), but in some cases no match was found. The diving surveys in August and September 2010 also revealed larger parts of timber than in June. This further confirms the fact that the site is sub-

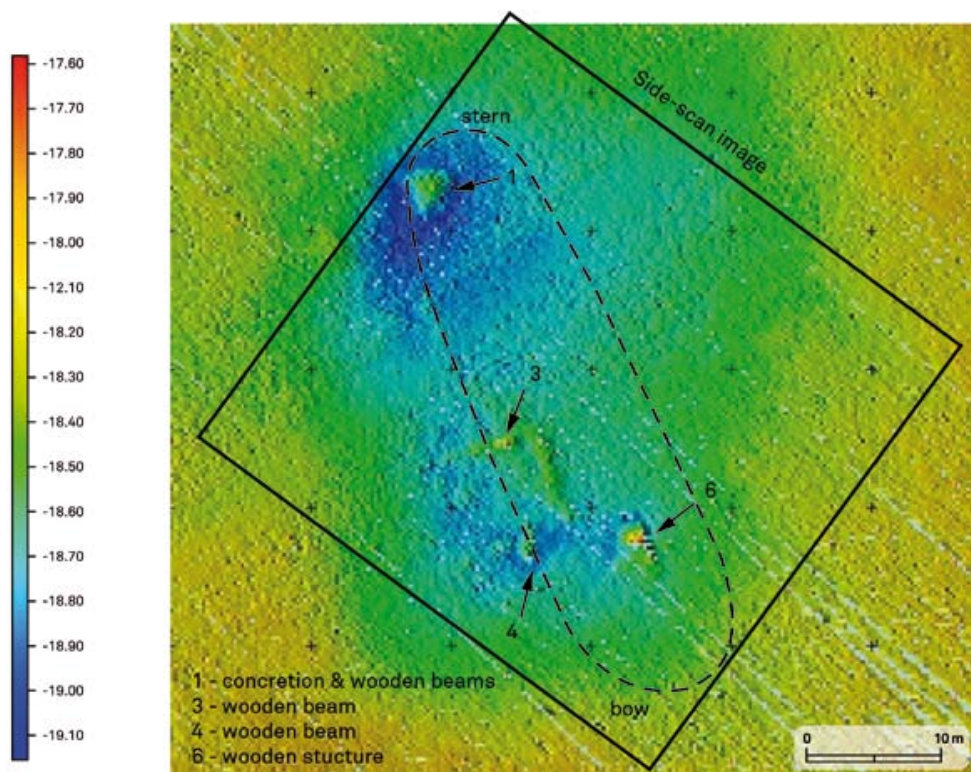
FIG. 8 Multibeam image obtained in 2009 from the 't Vliegende Hart wreck site (courtesy by MDK - Afdeling Kust - Vlaamse Hydrografie). Depth in m MLLWS (Mean Lowest Low Water level at Spring tide). The dotted line marks the (supposed) outline of the ship based on 1993 data (see fig. 6). Only few protruding wreck fragments are observed. Elongated features are most likely due to wooden beams or cannons. The stern remains stand out clearly. Numbered arrows refer to some of the wreck remnants observed in 2010 (see also fig. 9).
