# A preliminary assessment of the state of preservation of the wreck of the *Belgica*

David Gregory<sup>1</sup>, Poul Jensen<sup>2</sup>, Kristiane Strætkvern<sup>3</sup>,  
Tom Lenaerts<sup>4</sup> & Marnix Pieters<sup>5</sup>

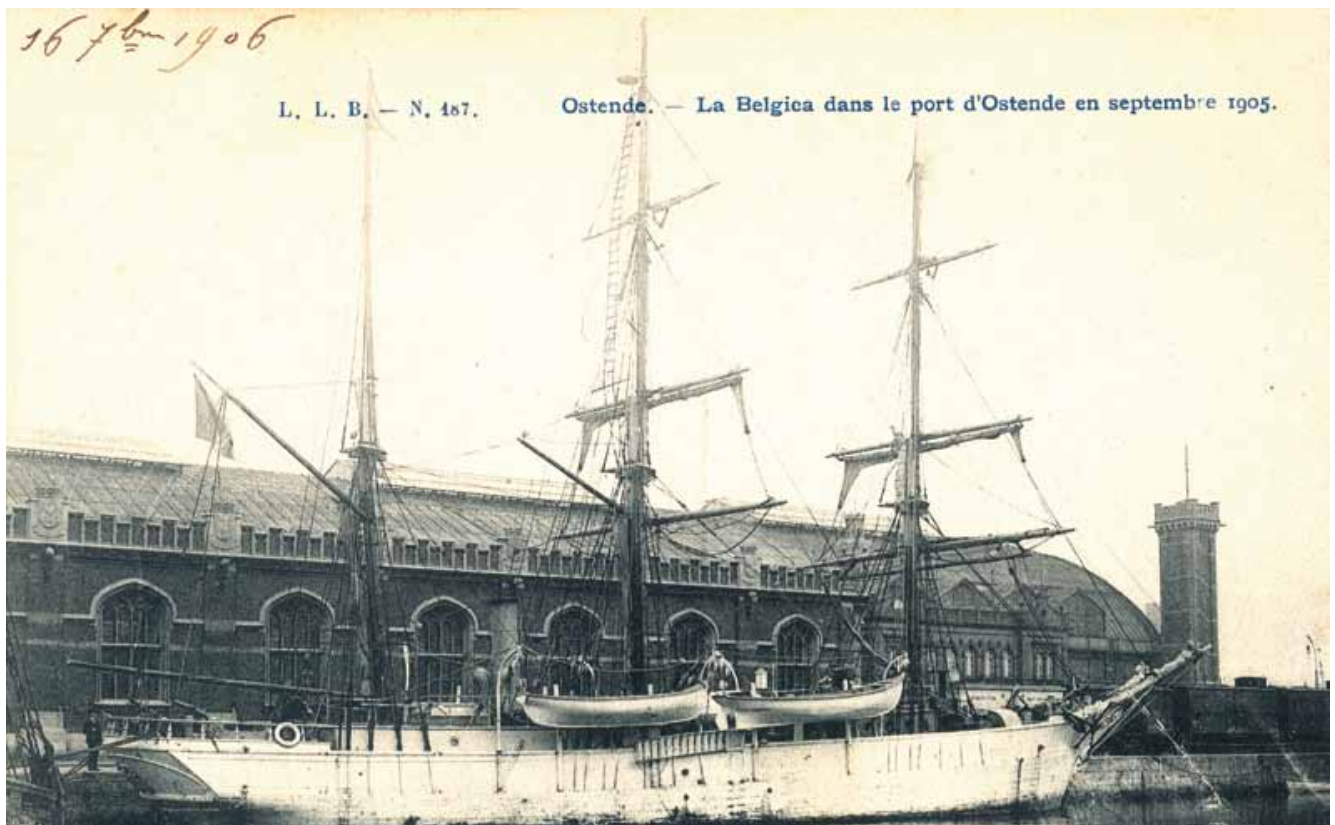
**FIG. 1** The *Belgica* lying in the harbour of Ostend, 1905 (photo courtesy Archives of the city of Ostend).  
*De Belgica in de haven van Oostende in 1905 (foto stadsarchief Oostende).*

The *Belgica* was a Norwegian whaler built in Svelvik in 1884 (fig. 1). She was designed and built by Johan Christian Jakobsen and her dimensions were 36 x 8 x 4 metres. She was built from pine and pitch pine on oak ribs. Her stern and bow being protected by four inch planks of greenheart (*Chlorocardium rodiei*), with the mid ship ice sheathing being made of oak. Her bow and stern were also strengthened above and below the water line with solid iron ribs. The bent shape of the bow below the water line enabled the ship to slide on the ice and to break it with its weight and movements. She was originally three masted and barque rigged weighing 263 tons and fitted with a 35 hp steam engine.

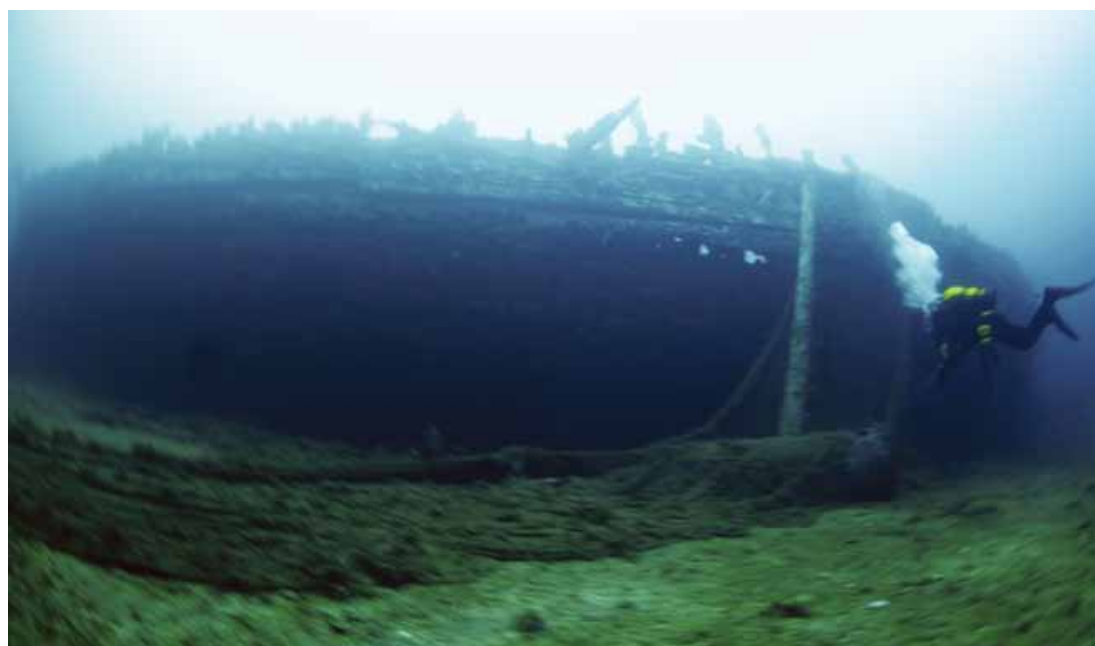
**FIG. 4** The wreck of the *Belgica* lying on the seabed, view on starboard side (Courtesy Tom Leys).

In order to obtain the necessary field data for the assessment of the state of the preservation of the *Belgica* two successive field campaigns were organised in the first half of 2008. The aim of the first campaign was to make a comprehensive photographic record of the wreck. This was carried out in February to ensure maximum underwater visibility due to limited algae in the water during winter months. In order to facilitate this documentation, a large fishing net that had been colonised with seaweed and was covering the central and lower parts of the wreck, was removed. A photomosaic of the wreck was taken (fig. 8) with overlapping pictures for the mosaic being taken along the longitudinal axis of the wreck, more or less at the same level above the wreck. This photomosaic allowed for the first time a visual overview of the entire wreck and was subsequently used to locate the samples taken for assessing the structural strength of the wood. The mosaic will also be used for the further archaeological analysis of the wreck. During this campaign, details as well as overviews, such as fig. 4, showing the starboard side of the wreck were also taken.

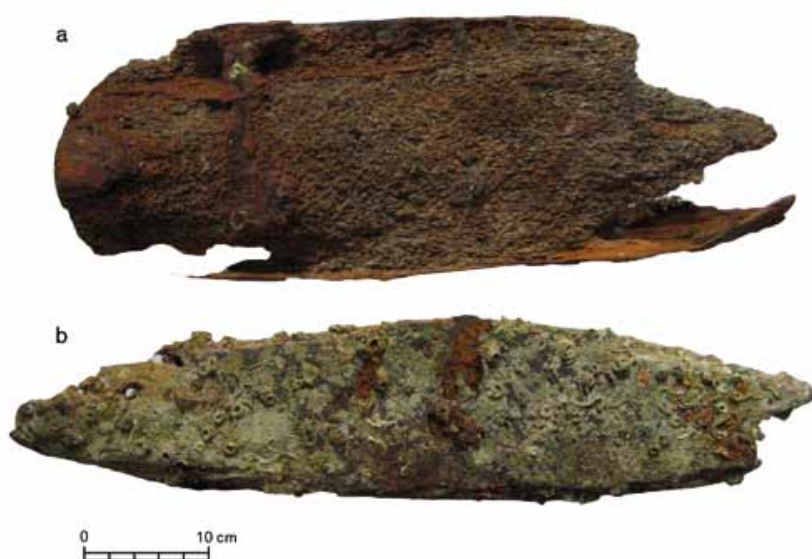
Figure 13 shows the two samples of oak wood taken to assess the activity of wood boring organisms. There were definite signs of colonisation by fouling organisms. These organisms tend to live on the surface of the wood rather than bore in to the wood (figures 14 and 15).

**FIG. 13** Two samples of wood taken from the wreck of the *Belgica*.  
*Twee houtstalen van het scheepswrak van de Belgica.*

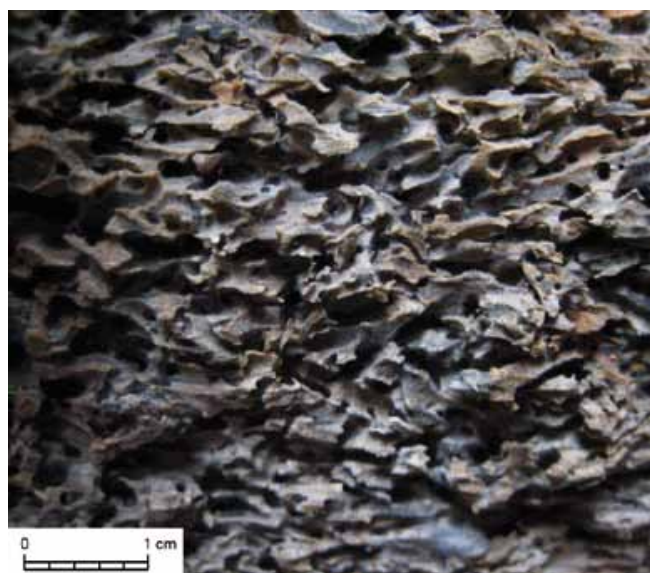
**FIG. 14** Surface of wood sample (figure 13a) extensively degraded by gribble.  
*Oppervlak van een houtstaal (figuur 13a) dat in sterke mate is aange-tast door paalpissebed.*

The surfaces of both wood samples were heavily degraded by the activity of wood boring crustacea (figure 14). Although there were no signs of living organisms on the wood, it should not necessarily be concluded that they are not present and active on other parts of the wreck.

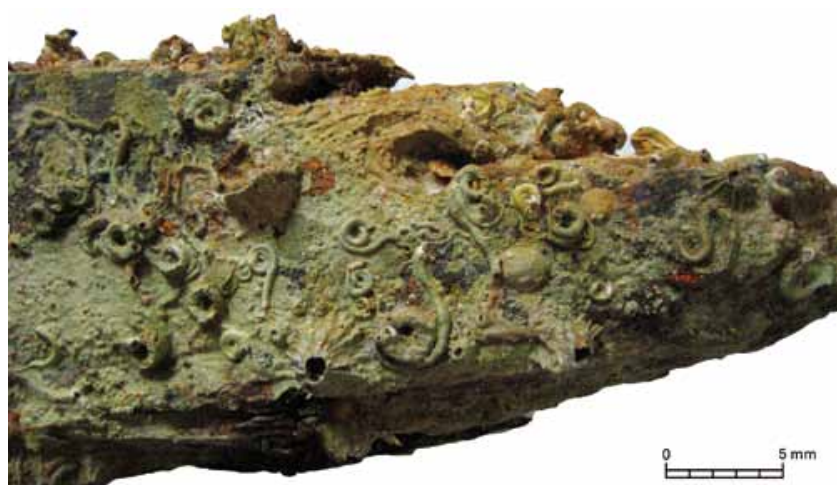
**FIG. 15** Close up of biofouling organisms on the surface of wood (figure 13b), including calcareous tubeworms and barnacles.  
*Detailopname van biologische aangroei op het houtoppervlak (figuur 13b) met inbegrip van kalkhoudende buiswormen en zeepokken.*
