Integrated assessment of the buried wreck site of the Dutch East Indiaman 't Vliegende Hart

Tine Missiaen¹, Ine Demerre² & Valentine Verrijken³

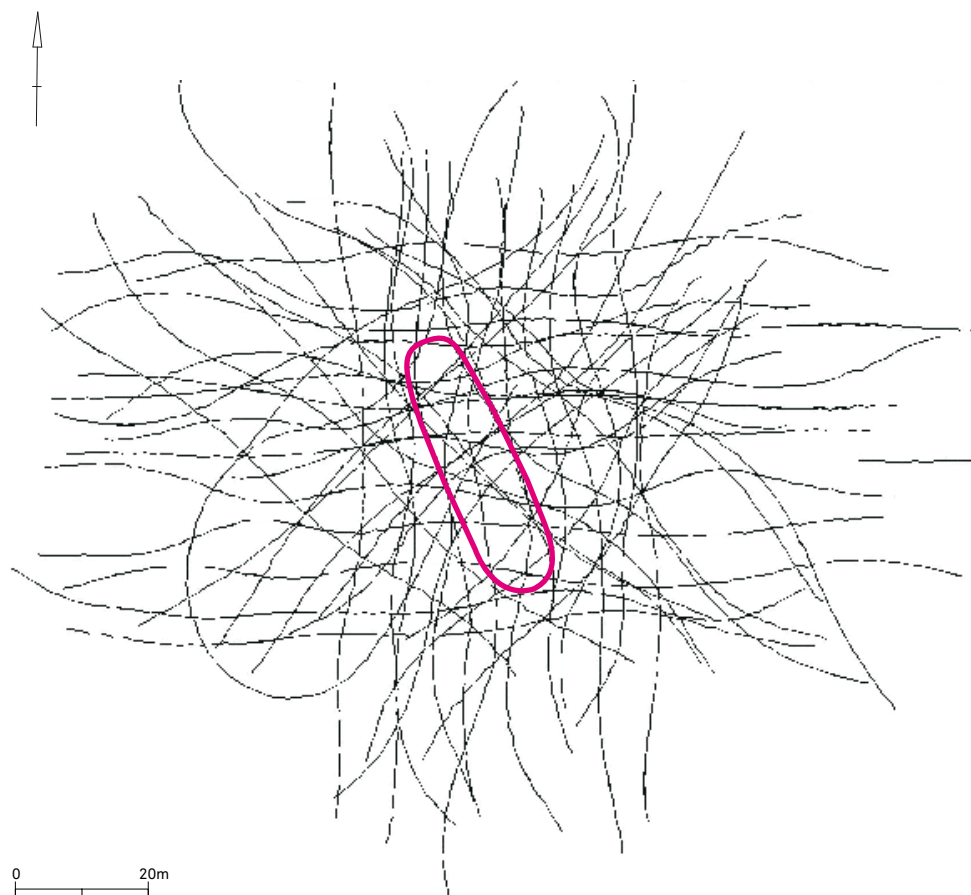
FIG. 10 Seismic network recorded over the wreck site of 't Vliegent Hart in 2010. The red ellipse marks the (supposed) location of the wreck. In total 49 profiles were recorded crossing the wreck at different angles. *Seismisch netwerk opgenomen over het wrak van 't Vliegent Hart in 2010. De rode ellips markeert de (vermeende) locatie van het wrak. In totaal werden 49 profielen opgenomen die het wrak kruisen onder verschillende hoeken.*

over the wreck site (fig. 10). Vessel speed was kept at roughly 3,5 knots, which resulted in high and regular seafloor coverage. The seismic data that are discussed in the following paragraphs were all obtained during this second survey.
